SEISMIC RESEARCH UNIT
UNIVERSITY OF THE WEST INDIES
ST. AUGUSTINE, TRINIDAD

GEOLOGICAL REPORT ON THE
ST. JOHN LANDSLIP, GRENADA

BY
HARALDUR SIGURDSSON

JANUARY 1981

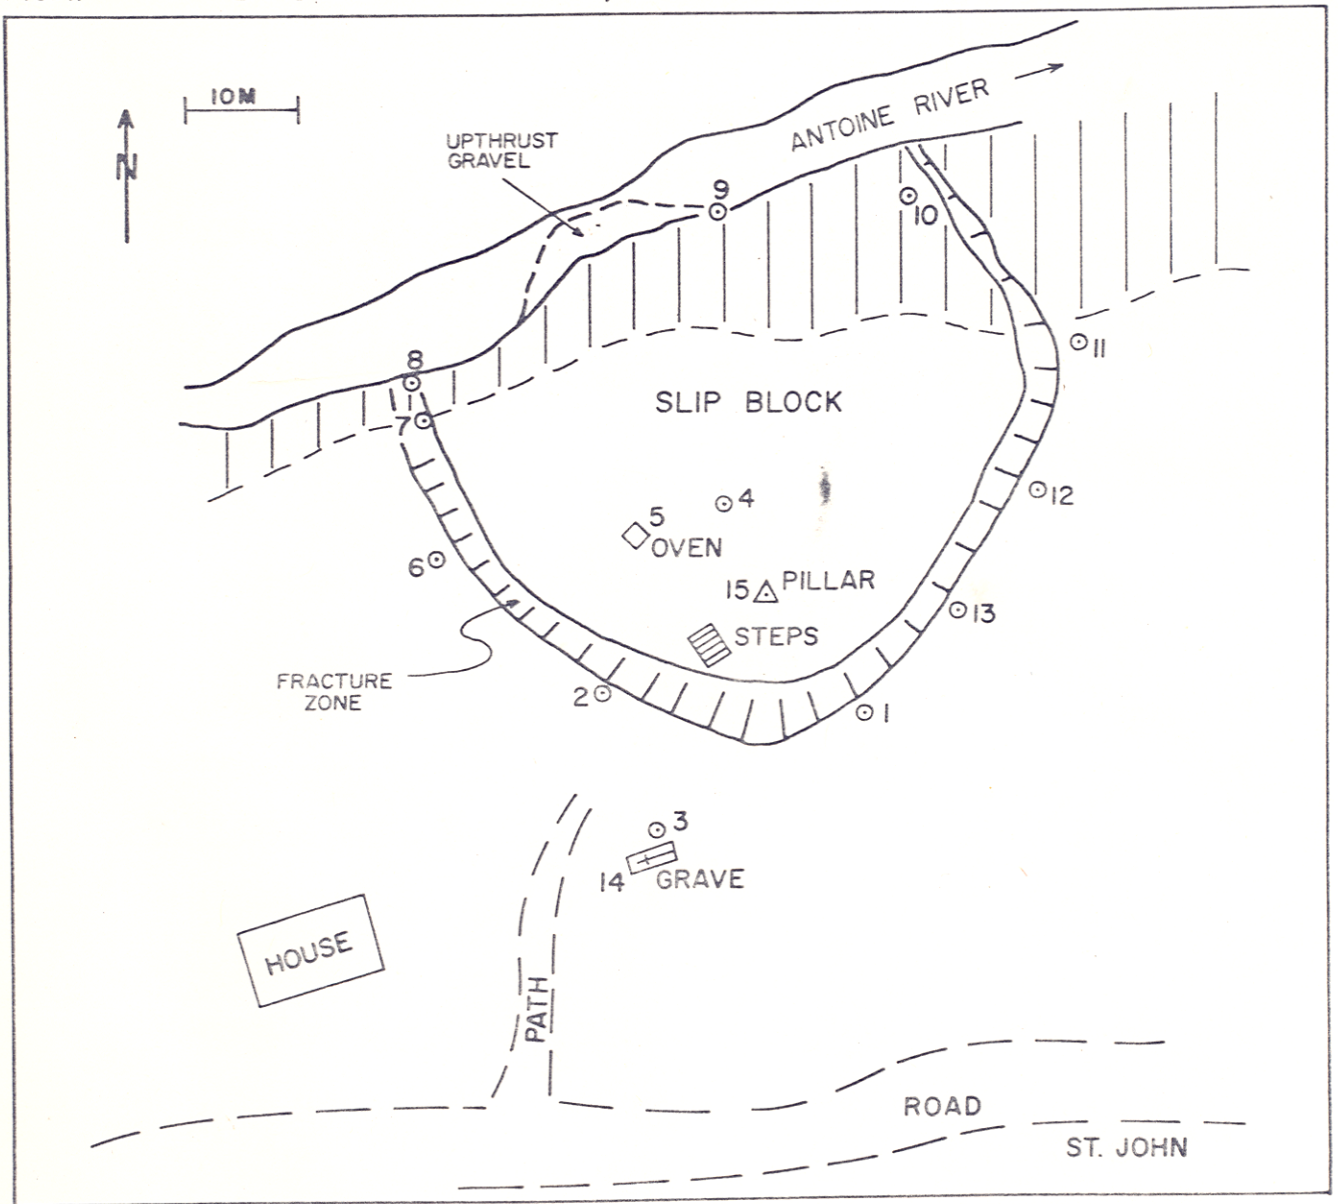
FIG. I. LANDSLIP IN ST. JOHN, GRENADA.

Investigations show that the St. John disturbance is a landslide of the steep southern bank of the Antoine River. The landslide affects a semi-circular area (Fig. 1) defined by an arcuate scar or fracture zone. The area affected is 2300 square meters or little more than half acre of land and extends about 60 m inland from the south bank of the Antoine River. On 18 January the headscarp generated by the landslide was a 4 m high cliff at the south end. The amount of vertical displacement is less on west and east portions of the arcuate fracture, or about 1 to 1.5 m. There are three gaping fissures present in the fracture zone at the southern point of the landslide. These are due to northward motion of the slipping block of rock.

In the Antoine River the landslide has pushed up river gravel and boulders from the southern river bank and thrust this material towards the northern bank. This motion has partially dammed the river, resulting in formation of a pool or small pond behind this dam.

Motion of the landslide was continuing during my visit to Grenada and the entire block moved 8 cm laterally during a 20 hour period on the 18 and 19 January.

Movement of the landslip should be monitored frequently by Government officials in order to assess the potential hazard. It is recommended that the distance from a fix point on the slipping block (Oven, point 5 on Fig. 1) to the headstone on a grave outside and south of the slip (point 14 on Fig. 1) be measured twice a week. On 19 January 1981 this distance was 28.33 meters. Location of data points on Fig. 1 is known to Mr. Charles Francis of the Ministry of Agriculture and it is recommended that he supervise further monitoring of the landslip, including damming of the Antoine River.

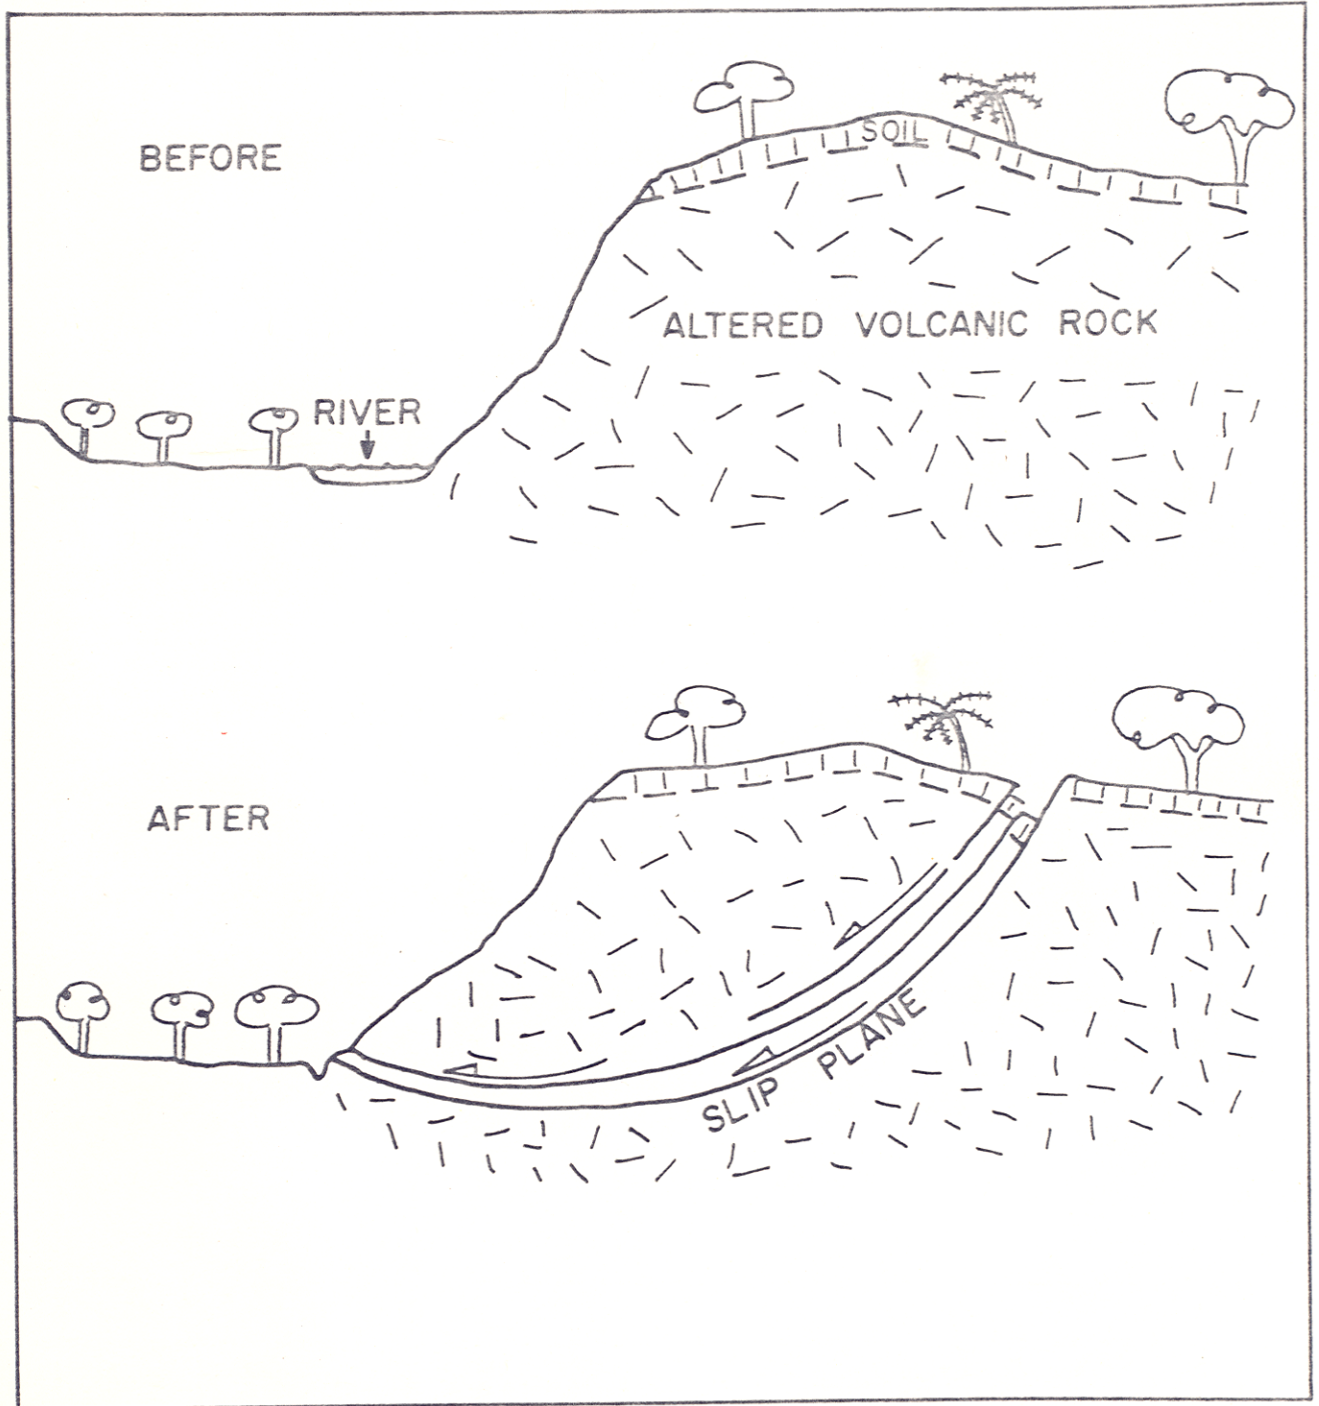
FIG. 2.

The St. John landslide is a common geologic phenomenon, related to slumping of steep banks or cliffs along curved shear planes. Such slips commonly have arcuate or horse-shoe shaped scars on the surface and the slipping block of rock is rotated along a horizontal axis as it moves down-slope. The process is schematically illustrated in Fig. 2. The bedrock of

this region is a friable, old and highly altered volcanic tuff (pyroclastic flow deposit) over 20 m in thickness. This rock has a very low yield strength and consequently is now unable to sustain its own weight in the 20 m high south bank of the Antoine River. The amount of rock affected or involved in this landslide is 23,000 m³ or 575,000 tons. At the time of writing, this mass has not yet reached a state of equilibrium and will therefore continue to slip.

The St. John geological disturbance is a common form of landslip, involving 2300 m² of land, which has slipped towards the Antoine River along an arcuate scar. Slumping of the steep river bank has taken place on a curved shear plane, causing a rotational slip (Fig. 2). This feature is a normal process of erosion and does not relate to any deep Earth processes, and is thus not due to volcanic activity or faulting. A total of 575,000 m³ of rock is involved. The slip is likely to continue, but at a decelerating rate.
