## INVESTIGATION OF THE WATERCOURSES AND MEASURES TO ALLEVIATE FLOODING IN THE PENAL/ DEBE REGION

<sup>1,2,3</sup>Design and Manufacturing Engineering, The University of Trinidad and Tobago, Trinidad

<sup>4</sup>Penal/Debe Regional Corporation, Trinidad

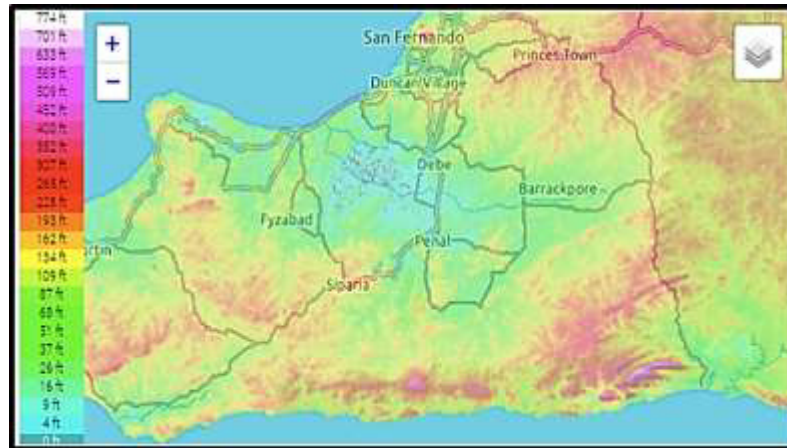
Figure 1: Topographic map of Penal-Debe region [4]

This study focused primarily within the Penal/Debe district. And so for the purposes presented here, the focus will be on the waterways, main rivers and tributaries which flow towards and into the Gulf of Paria through the Godineau River. Figure 2 below shows a topographic view of the area describing the contour of the land which is considered to be a main cause of flooding for citizens in lower lying areas.

Figure 3 thus correlates with Figure 2 which shows that the lower lying areas in the region are susceptible to flooding.

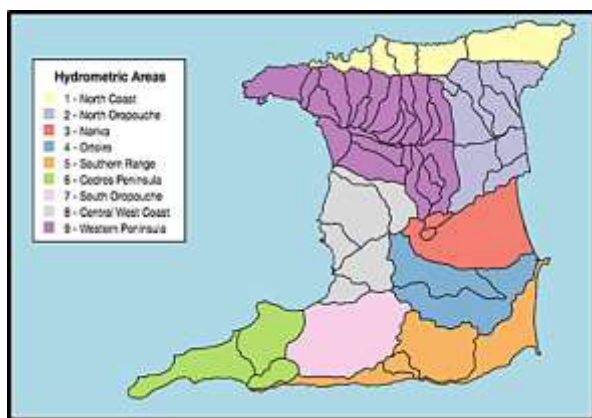
Figure 4: Watersheds of Trinidad [6]

The watersheds locally are shown in Figure 5 and looking at the municipal boundaries shown in Figure 6, about 60% of the Penal-Debe region falls within the South Oropouche watershed and is thus susceptible to flooding.

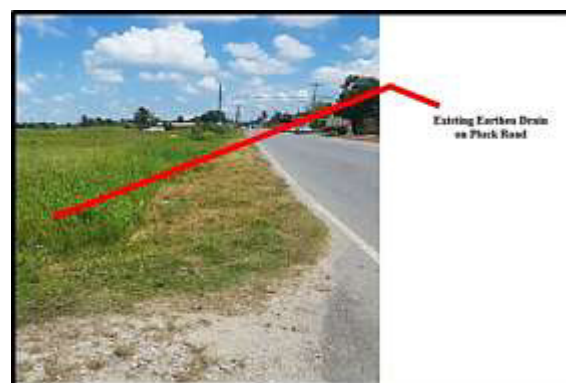
Figure 12: Earthen drain on Pluck Road, La Fortune

2. Consistency of drainages – Upon touring the region, visiting areas from Barrackpore East, Rochard, Clark Road into Penal/Debe, the consistency of drains which accommodate water is not the same. Some sections of the drainages are narrower causing bottlenecking of the flow at those points and some are even dirt drains which may need to be upgraded eg. As in Figure 13.
